Roundabout Concept Report - Wellington / Marlborough / William St, Longford -  
May 2021

### Heritage Corner.

## A plea to restore our Heritage Corner.

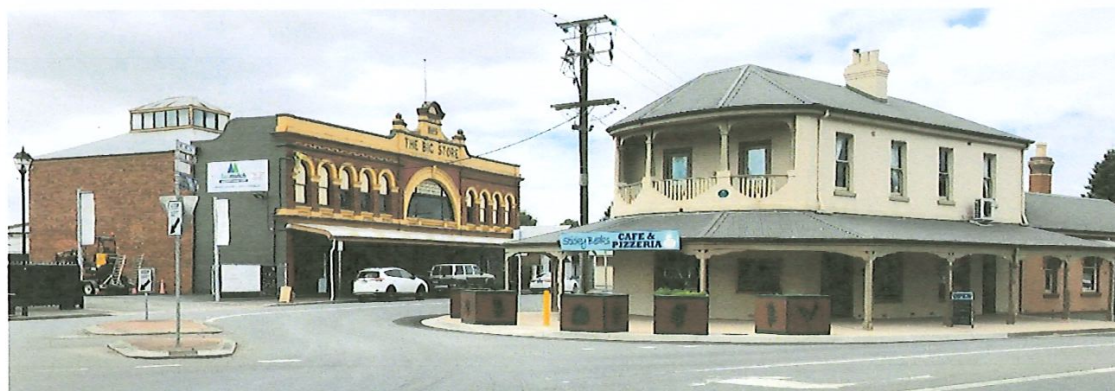
8. Photograph taken 8/02/2023, after the widening of the footpath and placement of five planter boxes.

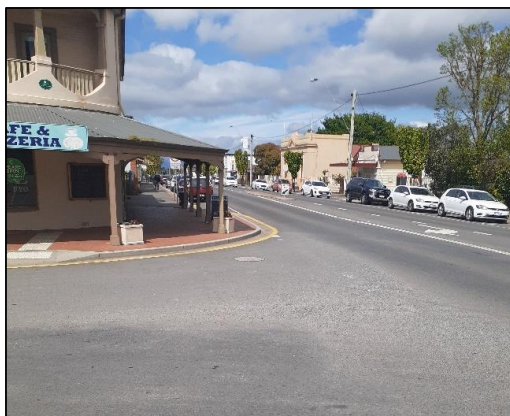
**Photograph 2. View from the traffic island south along Marlborough Street**

Photograph 2 is a view from the traffic island south along Marlborough Street. Due to the constrained nature of the intersection, heavy articulated vehicles turning left from Wellington Street must obstruct the northbound right turn lane on Marlborough Street. This option allows vehicle to move along Wellington Street south and turn left into Marlborough Street.

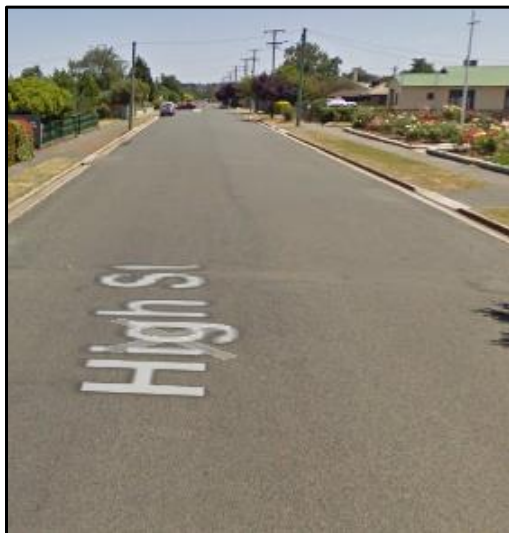
**Photograph 8. High Street**

Photograph 8 is an image of High Street. This option would in effect direct onto the left lane of High Street shown in Photograph 8, all traffic, including heavy vehicles, that currently move north along Wellington Street south between High Street and the Wellington Street and Marlborough Street intersection.

A consequence of this option is that the left lane of High Street, as shown on the left side of Photograph 8, would receive accelerated pavement and bituminous seal degradation due to expected increase in heavy vehicles.

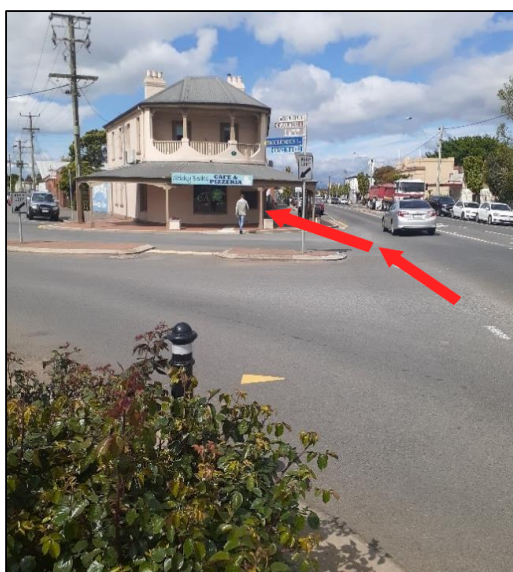
**Photograph 10. Sticky Beaks Café and the intersection**

Photograph 10 shows the Sticky Beaks Café and the intersection from the perspective of a motor vehicle travelling south along Wellington Street north and turning left into Wellington Street south. A traffic island on the centerline of Wellington Street south also acts as a refuge for pedestrians crossing Wellington Street. The red arrows in Photograph 10 show the approximate path of an errant vehicle that impacted the cafe building causing significant damage.

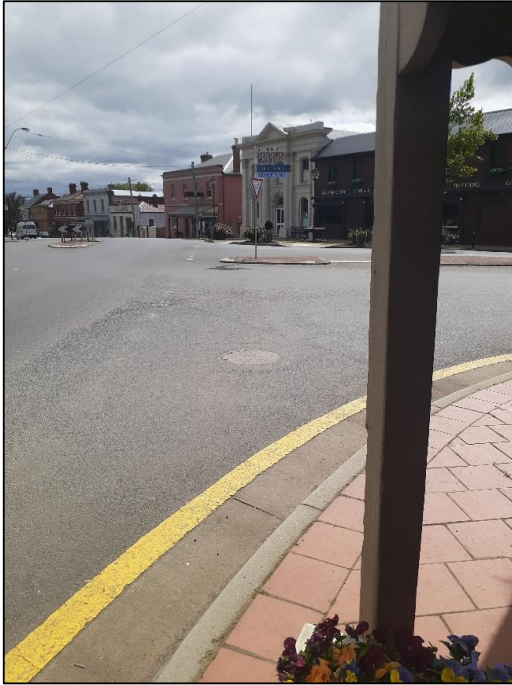
**Photograph 13. Intersection from the footpath at Sticky Beaks Café**

Photograph 13 shows the intersection and Wellington Street north from the footpath at Sticky Beaks Café viewing to the north. The errant vehicle that collided with the Sticky Beaks Café building passed to the right of the building awning column in Photograph 13.

This option proposes a raised island that will accommodate a suitable vehicular barrier in front of the Sticky Beaks Café building awning supports. The suitable vehicular barrier would be a product capable of dissipating the kinetic energy generated by an errant light motor vehicle striking the barrier. The intent of the proposed barrier placement would be to protect the pedestrians and building including the awning columns.

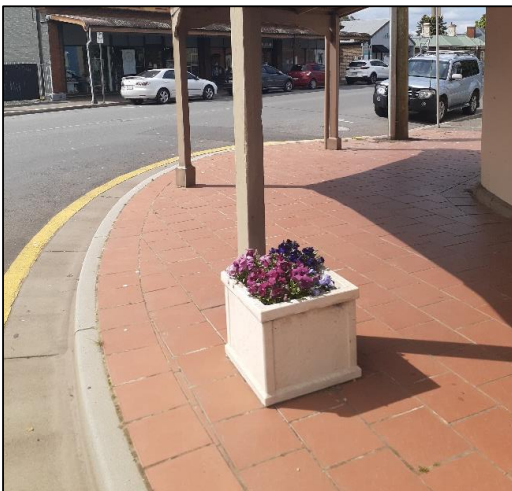
**Photograph 15. Sight distance from the pedestrian crossing along Wellington Street**

Photograph 15 shows the sight distance from the pedestrian crossing outside Sticky Beaks Café back along Wellington Street south. The sight distance is restricted by a parked vehicle and the building wall.

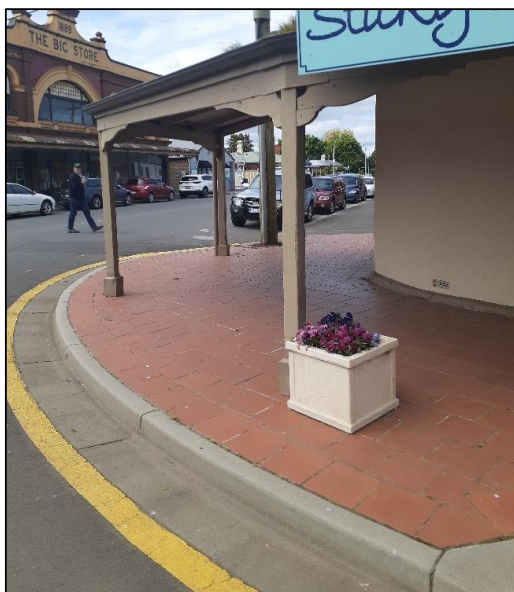
**Photograph 16. Improved sight distance from the pedestrian crossing**

Photograph 16 shows the improved sight distance outside Sticky Beaks Café back along Wellington Street south. The sight distance remains restricted by a parked vehicle.
